Jackson Hole, Wyoming Environmental Restoration Feasibility Report

Feasibility Report
and
Appendixes A - B

Final
July 2000

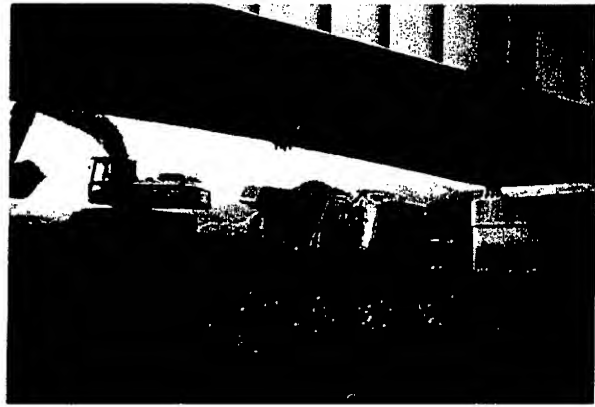
Channel management activity required additional heavy equipment in the immediate area of the Wilson Bridge. Aggradation of material was so excessive that the riverbed was lowered up to thirteen feet in this area. A small bulldozer was used to push the material out to the backhoe so that it could be loaded into the dump trucks
